REDUCED WOODPECKER DAMAGE IN ACZA TREATED UTILITY POLES

A presentation to American Wood-Preservers' Association
by Michael Brucato, Virginia Electric Power Company

May, 1994

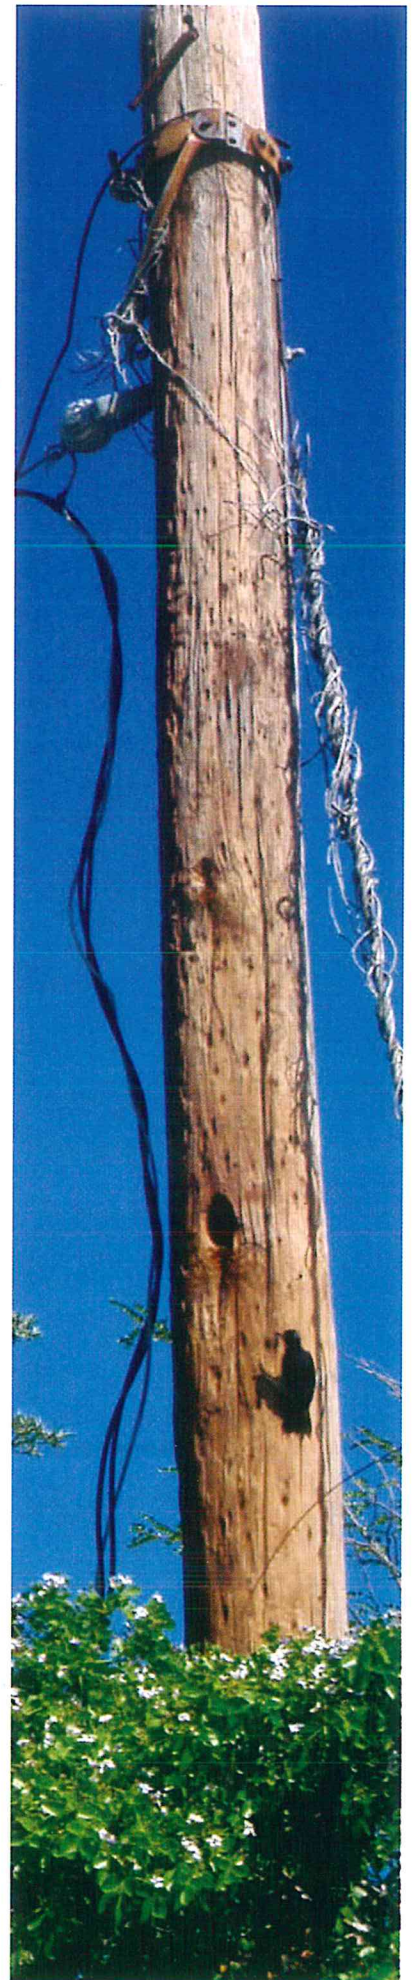
Here are the results:
 As the data indicates, the level of woodpecker activity was significantly less on the Chemonite treated poles than any others. There are questions regarding the Douglas fir creosote-treated poles on line 84, but there was not enough data to extract any meaningful information.
 The only single treatment in the study to show meaningful resistance compared to the other poles was Chemonite.

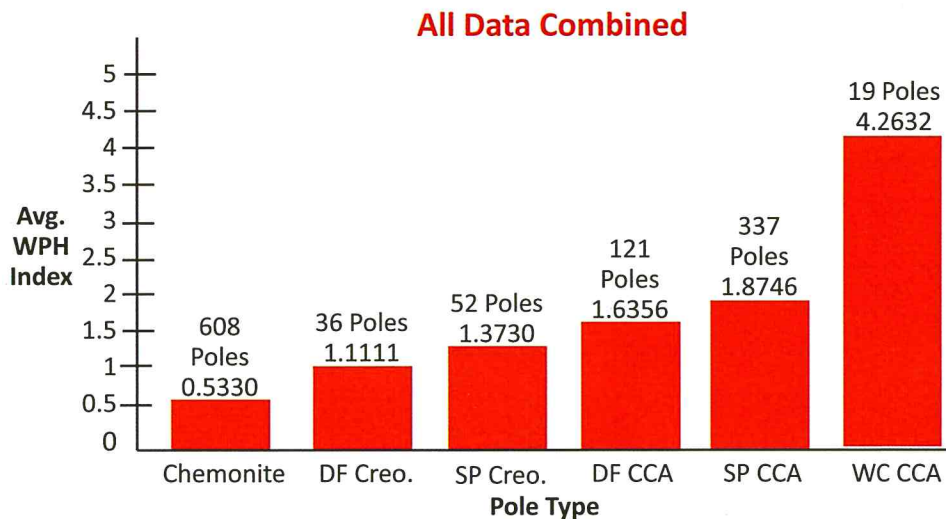
This study clearly shows that there is a definite tendency for woodpeckers to leave Chemonite-treated poles alone. The level of damage to the 608 Chemonite-treated poles was 71% less than the level of damage to the 565 other poles in the study. Chemonite cannot be considered “woodpecker proof” since some Chemonite poles were damaged, but the average damage on large numbers of poles shows more damage to poles of other treatment.

With 71% less woodpecker damage, we believe Chemonite-treated poles would be the cost effective choice in woodpecker-infested areas.
